*Photograph A- 1. The construction and failure of Teton Dam and Teton Reservoir in 1976 changed the physical and biological characteristics of the Teton River canyon upstream from the dam site. Today, the remnants of Teton Dam are a constant reminder of the changes that occurred, mostly from the filling and rapid drawdown of the 17-mile-long Teton Reservoir. USBR photograph by Tim Randle, 1997.*

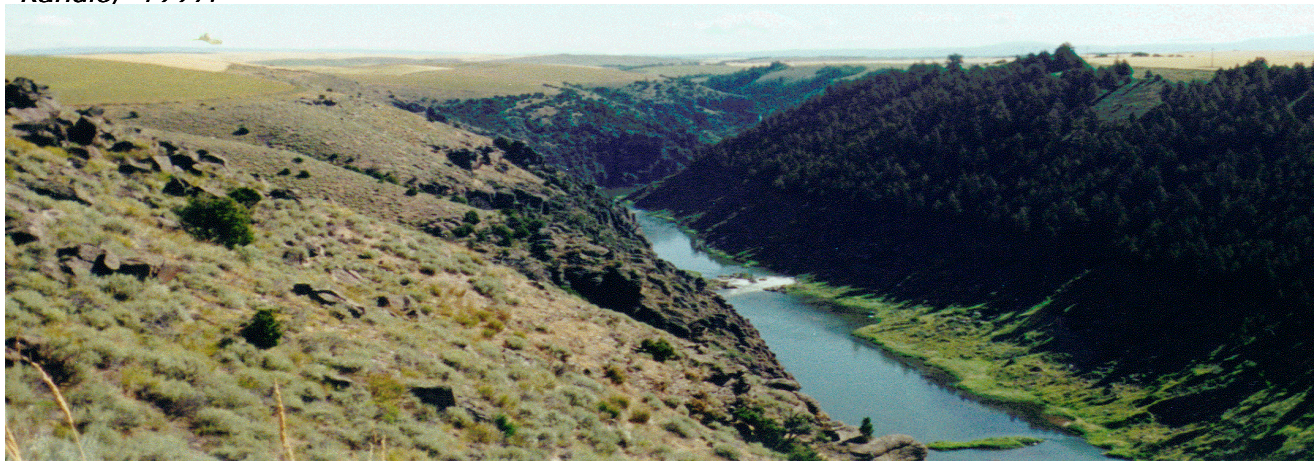
*Photograph A- 2. The Teton River canyon upstream of Teton Dam (located in Madison, Fremont, and Teton Counties, Idaho) is generally oriented in an east-west direction. The north-facing canyon walls support thick stands of conifers growing in thick, fine-grained soils. The south-facing canyon walls are steep, bedrock slopes that lack the well-developed soils and only support sparse stands of juniper and sage. USBR photograph by Tim Randle, 1997.*

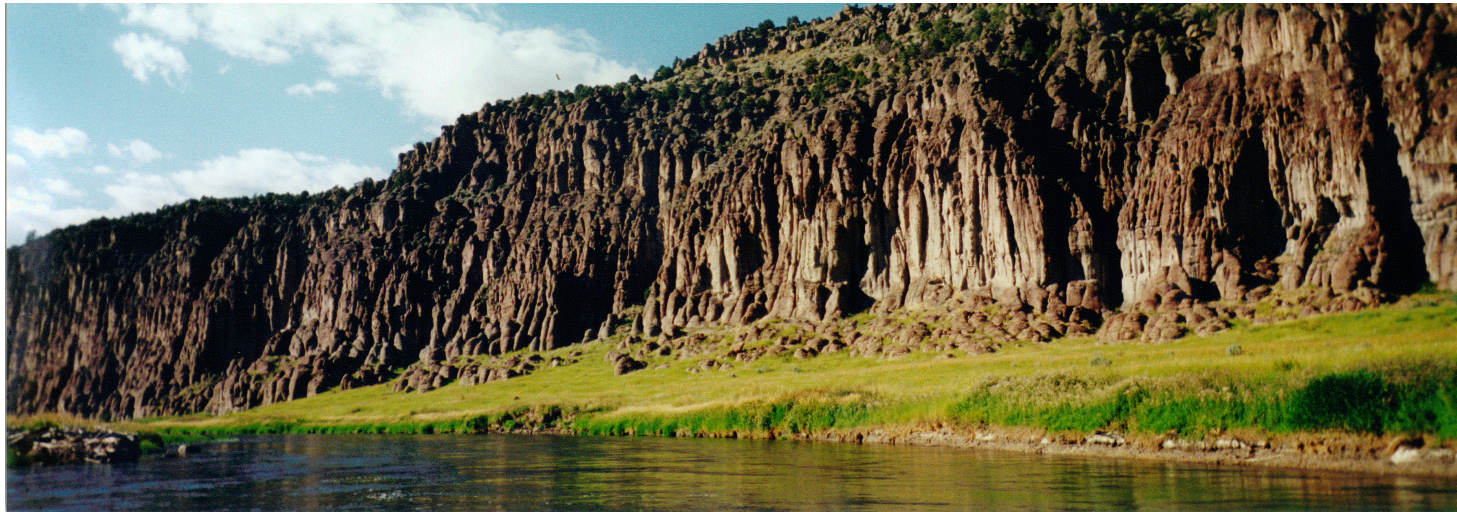
*Photograph A- 3. Upstream of the dam, the narrow canyon incised into the 1.2- Ma Huckleberry Ridge Tuff. The canyon becomes gradually wider in the downstream direction and is flanked by a low flood plain and higher terraces. USBR photograph by Tim Randle, 1997.*

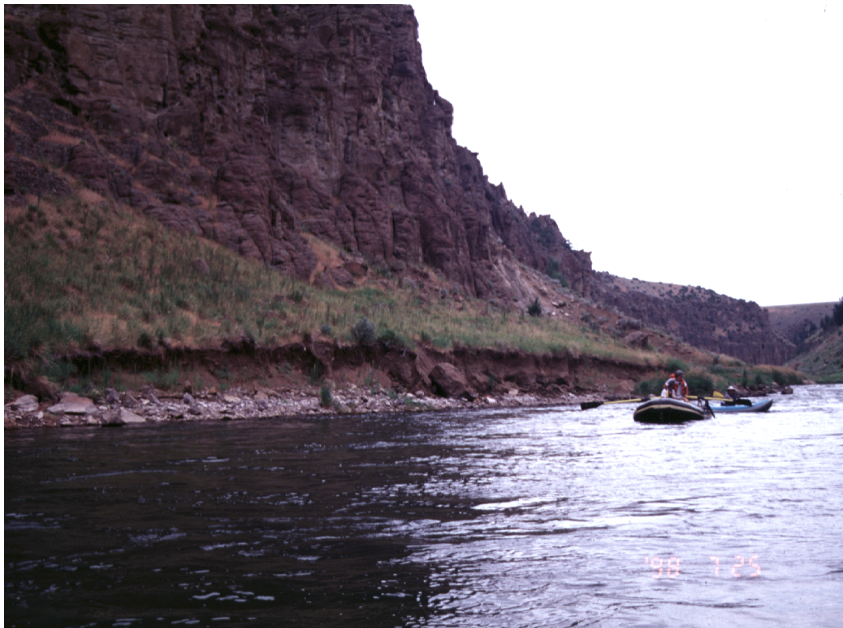
*Photograph A- 4. Early Holocene or late Pleistocene soil developed on colluvium is preserved along the south- facing canyon wall at this location. USBR photograph by Ralph Klinger, 1998.*

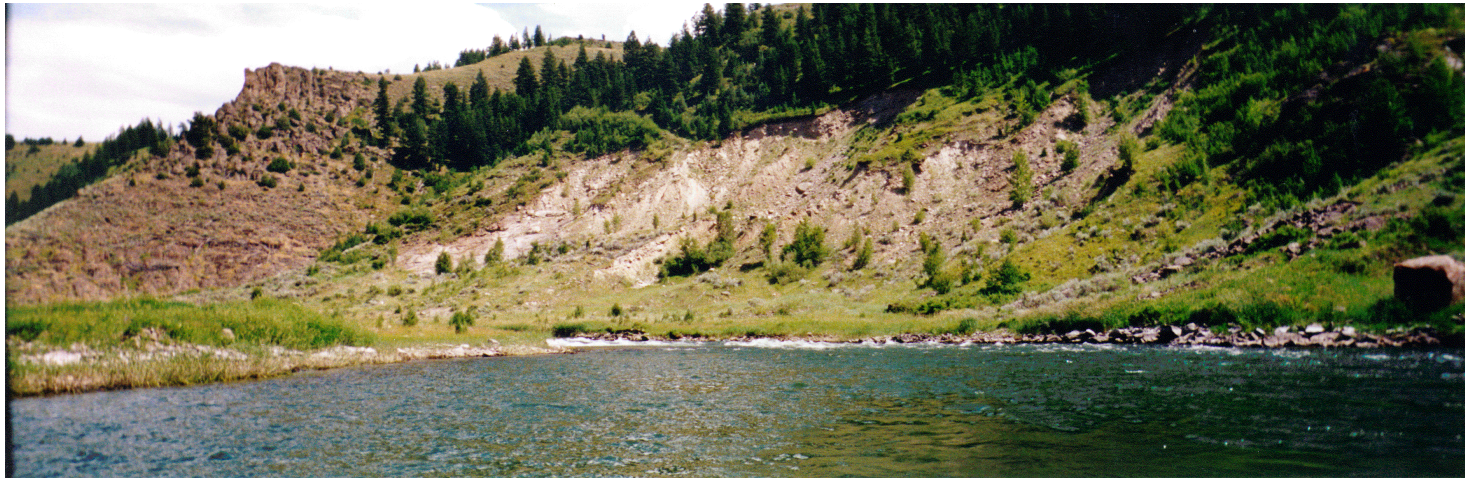
*Photograph A- 5. During the filling and rapid drawdown of the reservoir in 1976, hundreds of landslides occurred along the canyon walls, the majority of which are located on the north- facing canyon walls. USBR photograph by Tim Randle, 1998.*

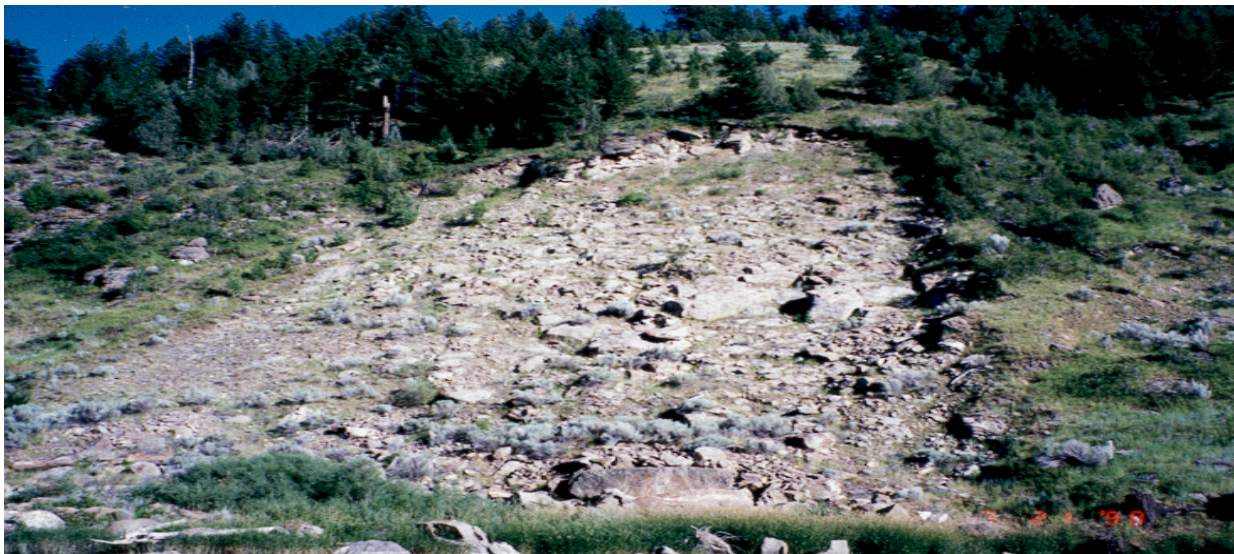
*Photograph A- 6. View of a translational slide along the south wall of the Teton River Canyon. Note the shallow depth of the landslide and the bedrock exposed in the slide surface. The material at the base of the slide ranges from sand to boulders up to 5 feet in diameter. USBR photograph by A.C. Lockhart, July 21, 1998*

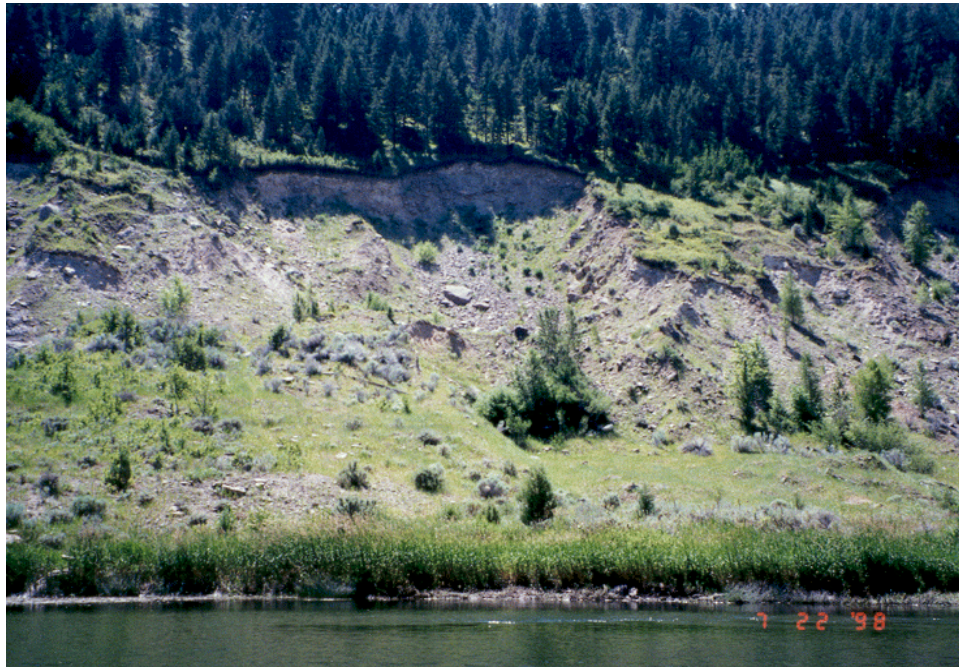
*Photograph A- 7.View of an earthflow slide along the Teton River Canyon between Spring Hollow and Canyon Creek. Note that this slide is in a thicker colluvium and has a deep headscarp. The material in the slide ranges from silt to large boulders. USBR photograph by A.C. Lockhart, July 21, 1998.*

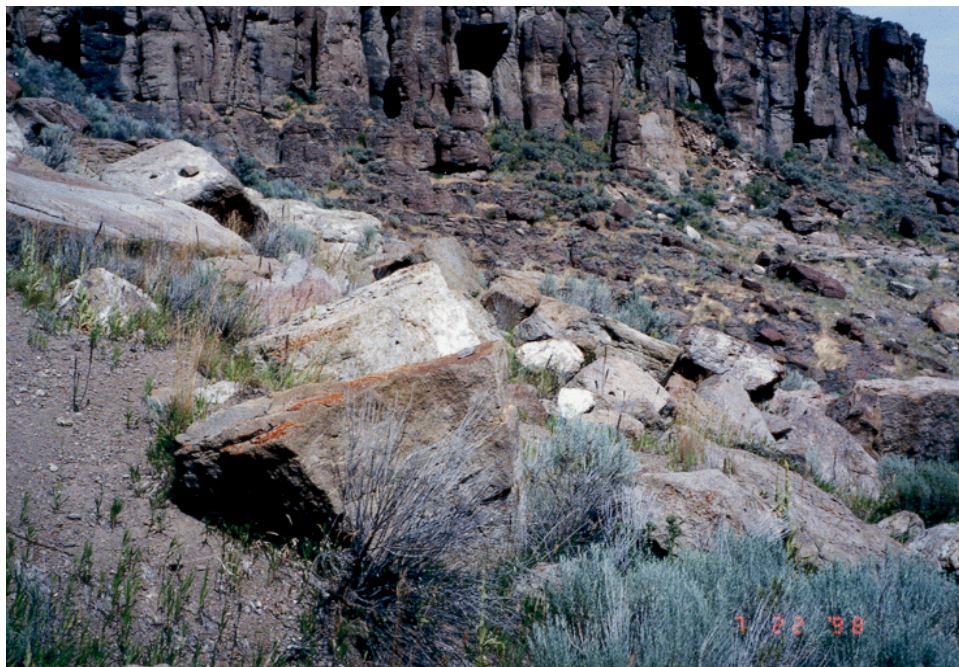
*Photograph A- 8.View of a rockfall slide along the south- facing Teton River canyon wall between Spring Hollow and Canyon Creek. Note the large blocks of rock at the base of the slope. The blocks range from 2 feet to over 10 feet in diameter, with the majority ranging from 3 feet to 5 feet. USBR photograph by A.C. Lockhart, July 21, 1998.*

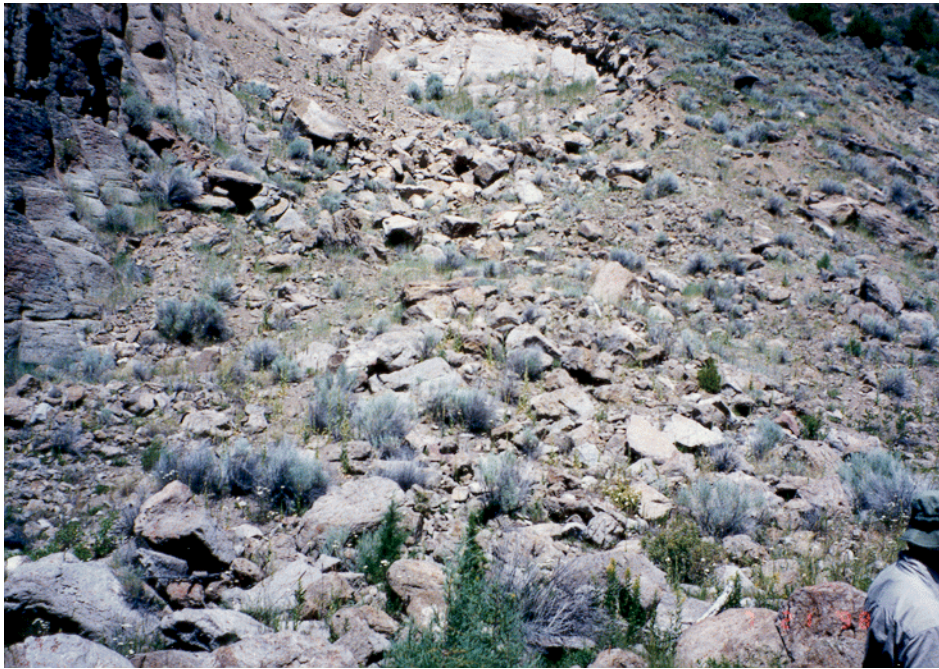
*Photograph A- 9.Landslide- material particle size data was collected at seven sites in the study reach. This landslide was located between Spring Hollow and Canyon Creek along the south canyon wall. This site was used to make a random size estimate of landslide debris. The majority of the blocks are in the cobble to boulder size range (up to 3 feet in diameter). USBR photograph by A.C. Lockhart, July 21, 1998.*

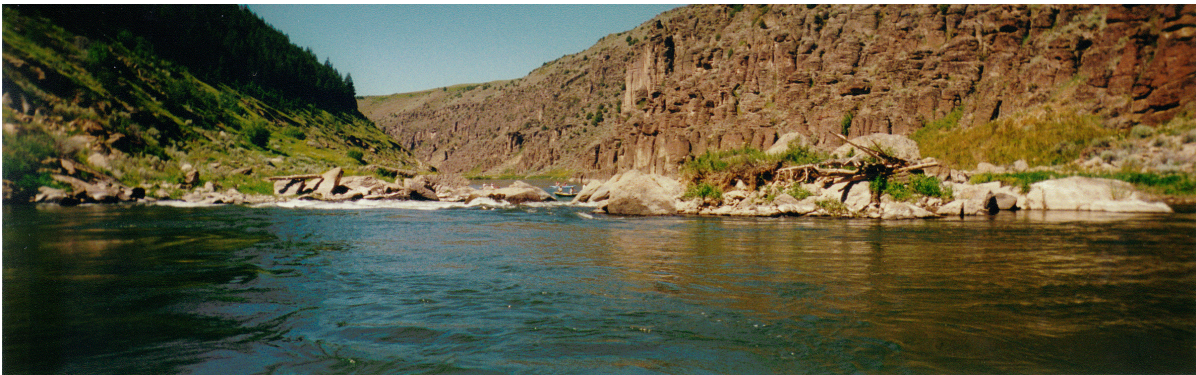
*Photograph A- 10.In the upper portion of the former reservoir area, the canyon is narrow and constricts the river. Landslide debris that slid into the river constricted the channel forming rapids that backed up pools. Eddies have formed where the channel expands downstream of the constrictions. USBR Photograph by Tim Randle, 1997.*
